Modification of The Oil Cooler to Avoid Oil Leaking in Generator Transformer PLTU Labuan “Moderator”*

P.G. Pratama^{1,*}, S. Santoso², S.H. Ramadhan³

¹Engineering Division, PIP Labuan Pandeglang, Indonesia

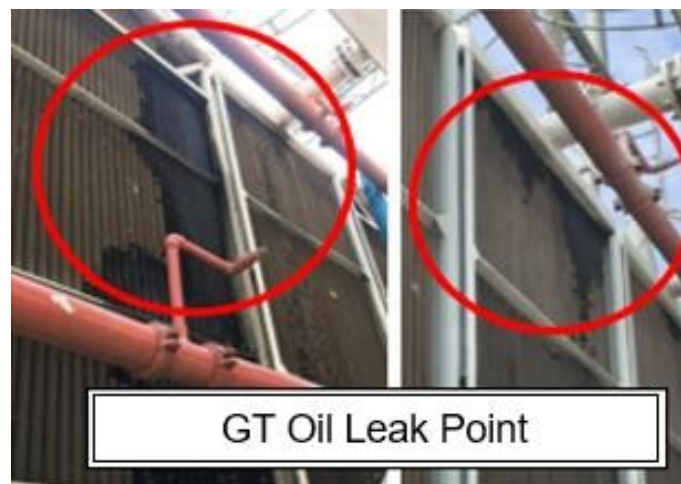
Figure 1. Oil cooler leak

The transformer is one of the main pieces of equipment of the power plant, so its reliability needs to be maintained because it affects the power production of the power plant (IEEE, 2010). The PLTU Labuan's Generator Transformer cooling system uses the OFAF (Oil Force Air Force) method through an oil cooler. Continuous operation without stopping leads to operational risk as well as increasing the probability of equipment failure (Nurhidayat, 2014). One of the downtimes that often occurs in generator transformers is an oil cooler leak caused by the expanding tube on the oil cooler being corrosive so that the expanded tube has a gap with the oil cooler body, resulting in a leak.

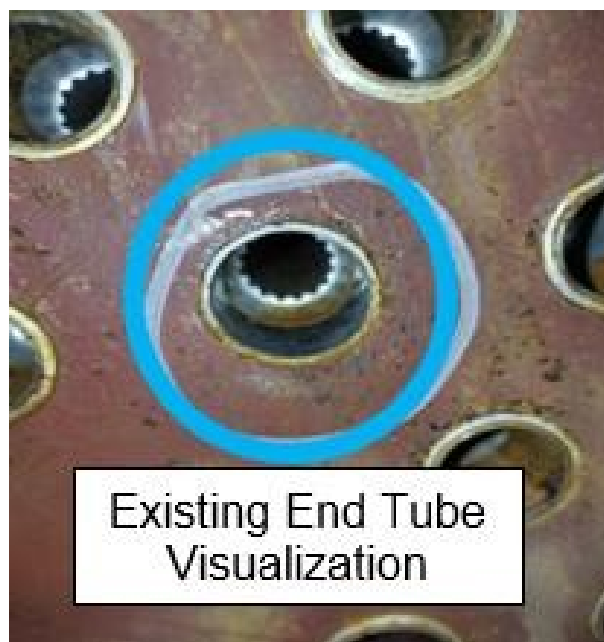
Figure 5. End Tube Design on Existing Oil Cooler

The root of the problem of oil leakage in the tube Oil Cooler transformer refers to the Material and Method factors. On the material factor, the tube oil cooler consists of 2 different materials, namely aluminum on the tube and for the expand tube using iron, so that it becomes one of the weaknesses that causes corrosion (Xi'an Xibian Components, 2008). Corrosion that occurs due to the presence of 2 different metals in one electrolyte so that the more anodic metal will be corroded, including the type of Galvanic corrosion (Utomo, 2009). In addition, because the tube oil cooler works at varying working temperatures, if there is an expansion, then the tube consisting of 2 different materials will result in internal stress which has an impact on disturbances in the oil cooler. From this, if the tube is corroded due to material differences, there will be a decrease in the function of the equipment, resulting in leakage.

In Factor Method, based on a field study, it was found that the leak of the Oil Cooler tube came from the upper side of the end tube where at that point the existing Oil Cooler was not strong enough in the buffer system to the header tube. So if there is corrosive on the end tube and there is no strong support, of course the oil distribution process cannot run according to its proper function, because it causes the end tube position to not accommodate the entire flow of oil used as a transformer winding cooler.

The picture above shows that in the existing oil cooler, the end tube only rests on the paired surface header. So when there is a corrosive part of the expanded tube and also the side effect of vibration caused by pressurized flow in the oil cooler tube, the end tube does not have sufficient support to be in its previous position.
