THE MECHANISM OF INITIATION AND MOTION OF THE RAPID AND LONG RUNOUT LANDSLIDES TRIGGERED BY THE 2008 WENCHUAN EARTHQUAKE

Wang, F.W.,*Sun, P., Cheng, Q.G., and Fukuoka, H.

Disaster Prevention Research Institute, Kyoto University, Uji, Kyoto 611-0011, Japan

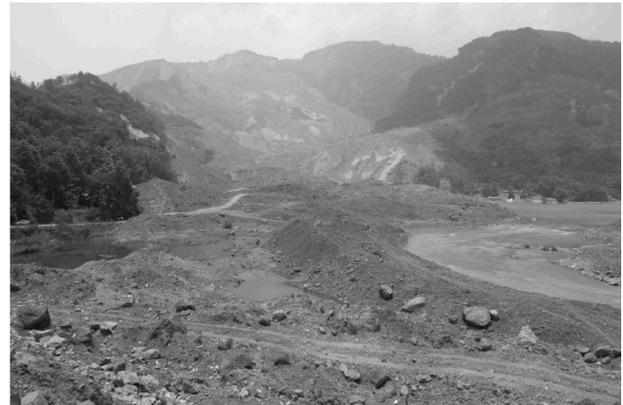
Figure 3: The rock sliding – debris flow in Donghekou Village. The flowing path was considered fully saturated.

A large scale rock sliding occurred in the back mountain at Donghekou Village because of the earthquake and moved down as a debris flow when the sliding mass entered the valley bottom and where the deposit was estimated to be in a fully saturated state, based on the photo showing the village before the earthquake and the post-earthquake investigation (Figure 3). Soil samples were taken from the site and simulation tests on the initiation and motion mechanism on this landslide were conducted; the results are presented in the following section.

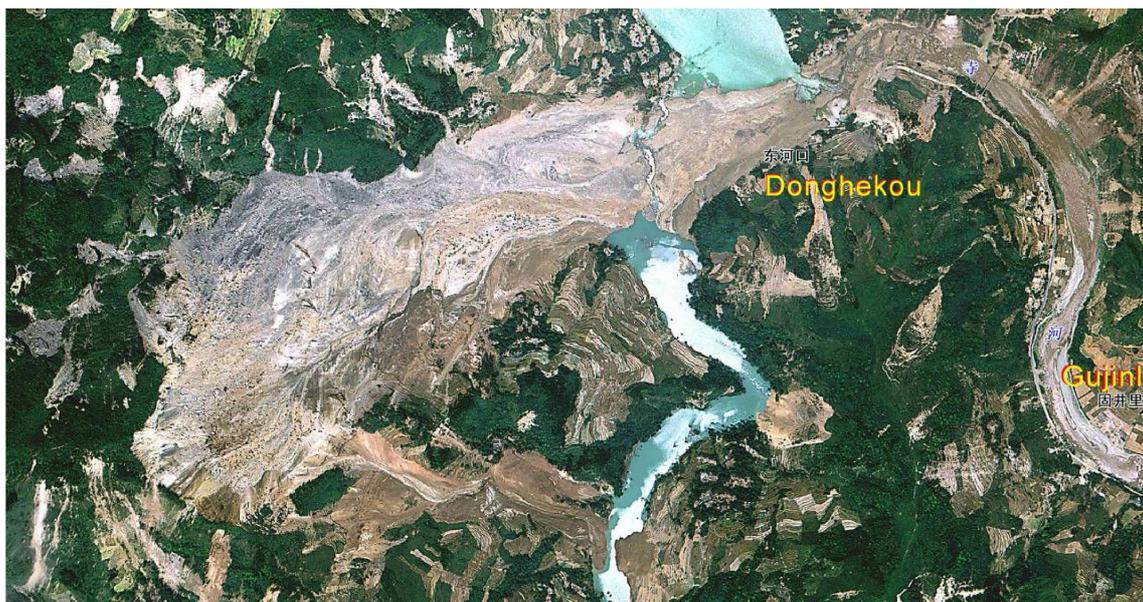
Figure 5: Air photo of the Donghekou landslide

In this test, the initial stress condition was set according to the longitudinal section of the Donghekou landslide (Figures 5-7). The real wave of the Wenchuan earthquake monitored at Bajiao Town in Shifang City by Seismic Monitoring Network, China Earthquake Administration was used. Through transforming the three components of the seismic wave to two components along the sliding surface (increment of shear stress) and perpendicular to the sliding surface (increment of normal stress), the input signals were formed (Figure 8) (Wang *et al.* 2000) and loaded to the sample (sample A from

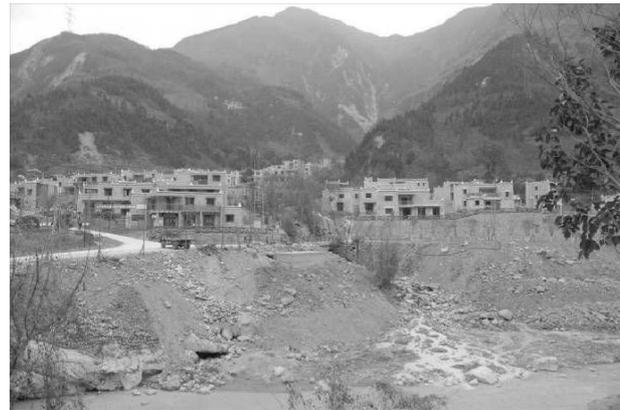
Figure 14: Secondary disaster such as debris flow should be considered in the reconstruction process. The photo was taken in February 2009 in Beichuan County

1. Avoid locating village in the landslide motion path, because the same event will occur in the future;
2. Avoid locating village and people on the landslide, because the landslide will deform easily with the seismic activity;
3. The attention should also be paid for landslide and debris flow during the reconstruction process for disaster mitigation in long period. We found that some new villages were located in debris flow prone area such as the Qian-tribe minority village in Beichuan shown in Figure 14.
