## Improvement of Andong Horseshoe Quality in Yogyakarta City to Support City Tourism

Alva Edy Tontowi\*, Mochammad Noer Ilman, Dawi Karomati Baroroh

Department of Mechanical and Industrial Engineering, Faculty of Engineering,  
Universitas Gadjah Mada, Yogyakarta, Indonesia

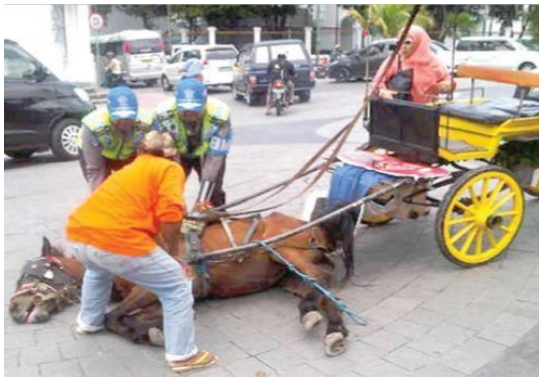
**Figure 1.** Horse slipping at Zero Kilometre Point of Yogyakarta City

Special Region of Yogyakarta is well-known as one of Indonesia's regions, which has become a mainstay tourist destination for local and foreign tourists. In 2014, around 3,346,180 tourists visited Yogyakarta, or it increased by 17.90 percent compared to 2013 (krjogja.com, 2016). Apart from the Keraton and Malioboro, Zero Kilometer Point (KM 0) is one of the tourist icons in Yogyakarta City. However, since it was renovated and reopened, the KM 0 point has brought a new problem in the number of *andong* (traditional horse-cart) horses that have slipped (Figure 1). The road

material is made of andesite stone and its convex shape makes the road more slippery and causes accidents to occur.

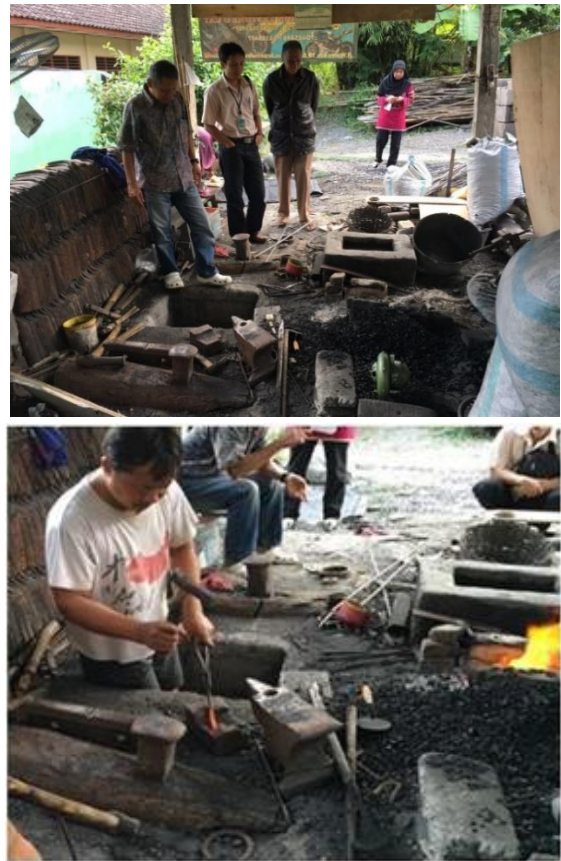
**Figure 2.** Initial conditions of horseshoe SME

After doing an initial survey of Yuni's SME, we found that the operational process of that SME was still quite optimal. However, the product was not standardized, and the workplace did not apply the 5S principles (Figure 2). 5S is an approach introduced by Toyota company Japan to organize, order, clean, standardize, and continuously improve a work area (Agrahari *et al.*, 2015). It is one of the efficiently working tools of lean manufacturing. Steps of the 5S process are 1) Sort (Seiri), 2) Set in order (Seiton), 3) Shine (Seiso), 4) Standardize (Seiketsu), and 5) Sustain (Shitsuke). Without 5S principles, Yuni SME's productivity may become inefficient, whereas that SME is the main supply of horseshoes in the Special Region of Yogyakarta Province.

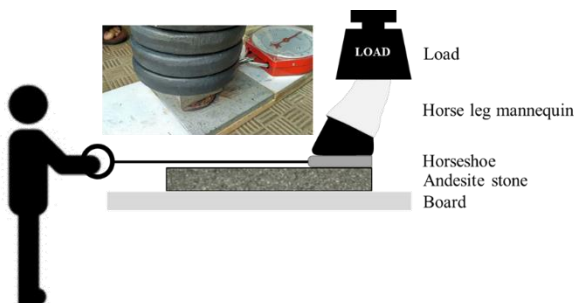
Figure 4. Friction testing mechanism

The hardness testing was done using the Brinell formula (equation 1), while friction testing was carried out by applying the mechanism as shown in Figure 4.

There are currently six sizes of horseshoe products in Yuni's SME (shown in Figure 5). The friction test on the existing horseshoe design was carried out on all sizes in two conditions of andesite (wet and dry testing). The friction testing mechanism is illustrated in Figure 4. After testing, the average friction force on wet andesite is 0.387, and dry is 0.4475 (with the value of friction for each size shown in Figure 6).

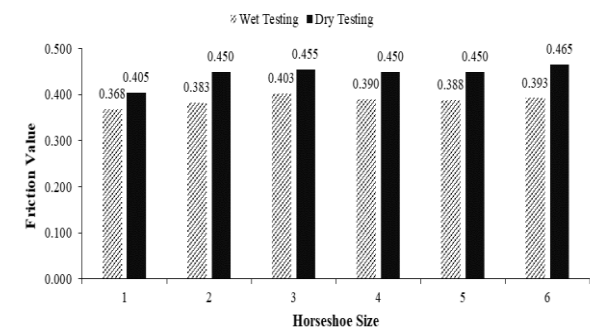
Figure 6. Friction testing result of the existing horseshoe for each size

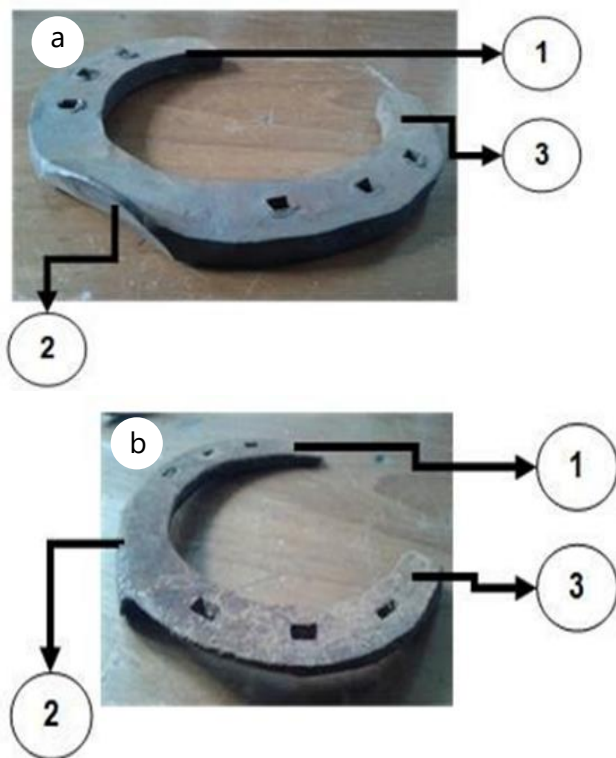
**Figure 7.** Thickness testing result of existing design: (a) before; and (b) after usage

This test was done by measuring horseshoe products' thickness before and after the usage for one week. Measurements were made using a micrometer in three points—the measurement points as shown in Figure 7. The thickness of the horseshoe before usage is 8.30 mm (point 1), 6.62 mm (point 2), and 7.40 mm (point 3), while after use for one week, the thickness changed to 3.67 mm, 3.58 mm, 5.93 mm for point 1, 2, 3 respectively. Based on the comparison results, it can be seen that points 1 and 2 have the most significant reduction in thickness. Because the horse's legs are running in a kicking motion so that the horseshoe is more easily worn or eroded in those points. Besides, point 1 is the outer part that causes the most direct contact with the road surface. Based on this thickness analysis, it can be used to determine the rubber pads' optimal location on the new design of horseshoe products, especially to increase the redesigned horseshoe's service life.

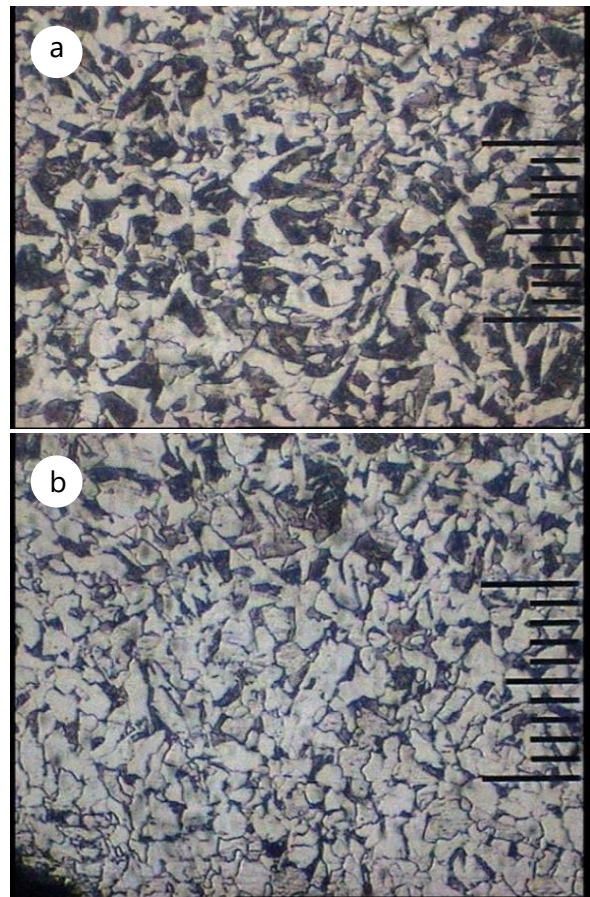
**Figure 8.** Microstructure analysis of horseshoe before usage

Figure 8 (a) shows the inner microstructure of the new horseshoe consisting of ferrite (light color) and pearlite (dark color), where the ferrite phase is relatively soft while the pearlite is harder. From the microstructure, it can be ascertained that the horseshoe material is made of medium carbon steel with a carbon content (C) of around 0.3-0.4%. Furthermore, the outer microstructure (Figure 8 (b)) shows that the ferrite phase (light color) is more dominant. This structure means an inhomogeneity in both composition and hardness where the outside is softer than the inside. As a result, horseshoes are prone to wear and tear.

Metal mechanical properties, including hardness, tensile strength, and toughness of metal, can be analyzed by considering the metal's microstructure analysis. Figure 8 showed the horseshoe material's microstructure before usage, while Figure 9 is after usage, which initial "a" for inner and "b" for outer.

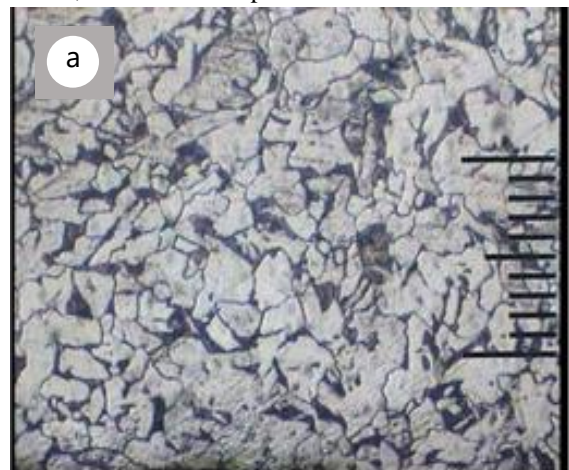
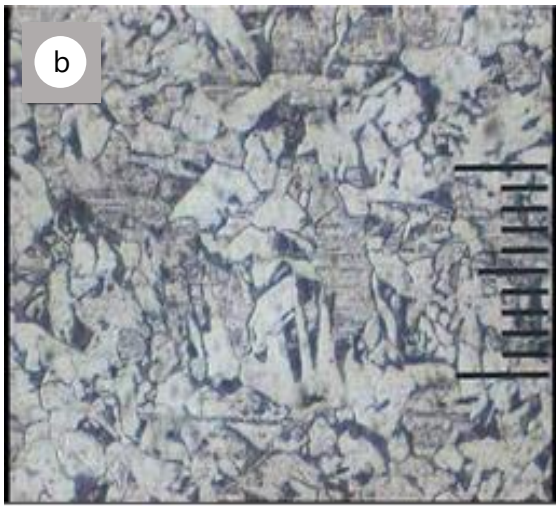
Figure 9. Microstructure analysis of horseshoe after usage

From Figure 9, it can be seen that the amount of ferrite (light color) is more than pearlite (dark color), so it is confirmed that this type of material is softer than the material in Figure 8. It is necessary to increase hardness through surface treatment such as carburizing, nitriding, or cyaniding to improve wear resistance to the horseshoe product. Of the three methods, carburizing is a more practical method. Carburizing is done by placing the horseshoe material in a stainless-steel box and then sprinkling it with charcoal powder and about 5% BaCO<sub>3</sub> (barium carbonate) as an activating carbon (BOC, 2016; and Kwietniewski *et al.*, 2013). As a result, the C content on the surface of low carbon steel becomes high so that the hardness increases, which means that the horseshoe's wear resistance increases.

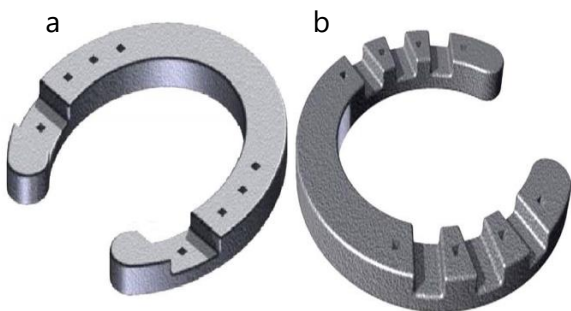
Figure 10. 3D model of horseshoe redesign: (a) design A (with rubber pads); and (b) design B (serrated/ without rubber pads)

Based on the several technical testing results of the existing horseshoe product, redesign of the horseshoe is one of the best solutions to solve this problem. There are two alternative designs which offered including a) a horseshoe with rubber pads as design A and (b) a serrated horseshoe without rubber pads as design B (can be seen in Figure 10 and Figure 11).

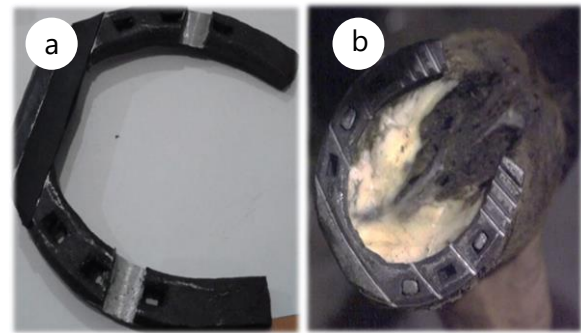
Figure 11. The prototype of horseshoe redesign: (a) design A; and (b) design B

Several tests were carried out on horseshoes that had a rubber pad (design A). The test evaluates design A by implementing rubber composition ranging from 0% to 100% rubber at the bottom of the horseshoe in wet and dry conditions of andesite stones (Figure 11). After testing, it was found that the optimal horseshoe according to the target was a horseshoe with a 40% rubber composition. That composition can increase the friction value by 10% in dry conditions and 15% in wet conditions (Figure 12). Furthermore, testing was carried out on horseshoes with 40% rubber pads (design A) and horseshoes serrated without rubber pads (design B).

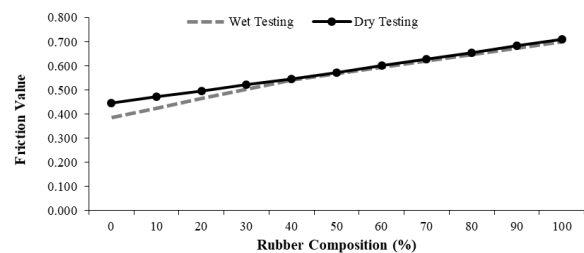
Figure 12. Testing of design A with rubber composition (0-100%)

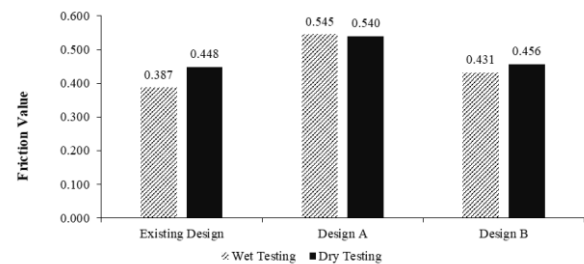
Figure 13. Comparison of the friction value among three designs

Based on Figure 13, it can be seen that the horseshoe with the addition of 40% rubber pads (design A) has the highest friction value on the andesite surface compared to the other two horseshoes designs. It shows that this horseshoe design can be continued to direct field testing to determine the level of movement stability of the horse cart. Here is a picture of the selected horseshoe prototype - design A (Figure 14). After conducting field experiments using the selected design, it was found that the addition of rubber was able to increase the friction value between the poultice and the road so that it was not slippery and made the horse cart run stably.

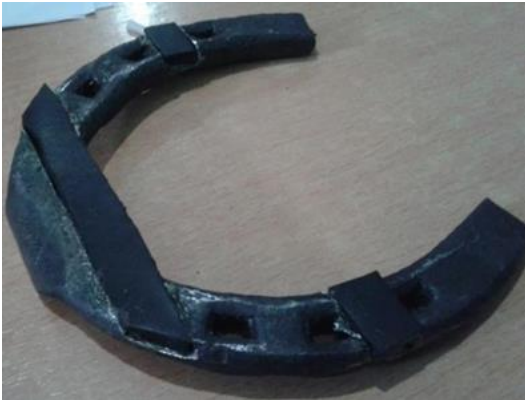
**Figure 14.** A prototype of optimal design of horseshoe (40% rubber pads)

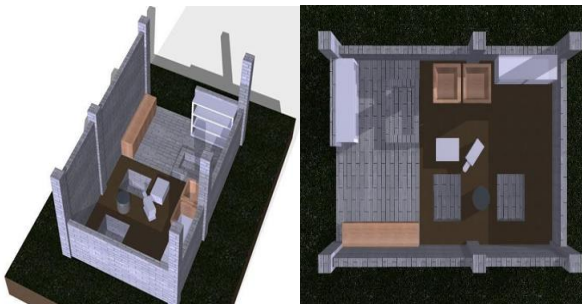
**Figure 15.** New layout design of horseshoe's SME

The initial layout was still not well organized, and the absence of 5S work principles was the focus of improvements suggested for this study. The following is a 3D design of the proposed layout design for horseshoe's SME (Figure 15).

The renovations were done by making the walls to a height of about 80 cm to prevent the incoming wind and provide a cool feeling to the workers. Also, renovations were carried out by procuring cabinets as containers for storing finished tools and horseshoes.

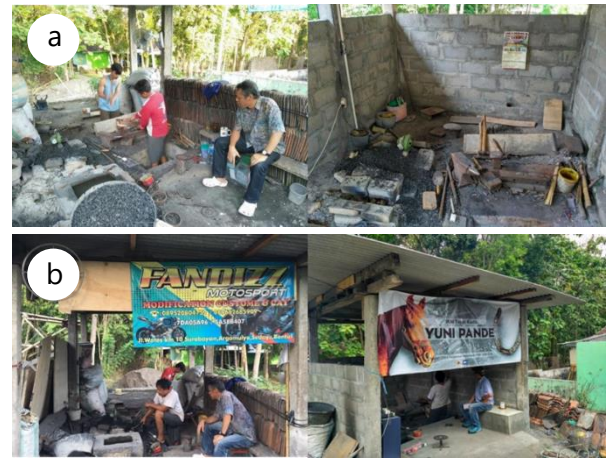
**Figure 16.** Comparison workplace of the horseshoe's SME: (a) before; and (b) after improvement

The finished product can be placed in a cupboard or on the shelf according to its size. With cabinets, SMEs can apply the 5S principle. Figure 16 shows the improvement in the horseshoe's SME condition before and after the work layout improvements.

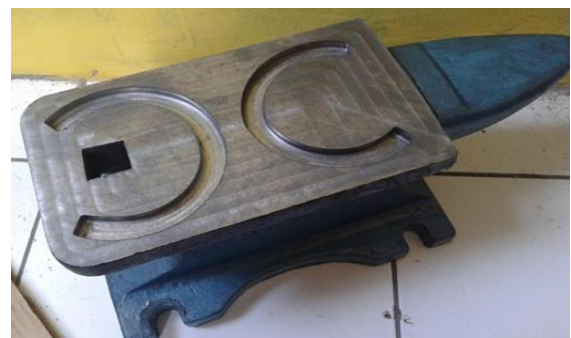
**Figure 17.** New tool for printing horseshoe

In order to support the increase in the quantity and quality of horseshoe products, improvements to the SME layout are not sufficient. They need to be supported by improvements in working methods. The initial process is still a conventional method of forging and cannot support standardized product quality. Therefore, to maintain and improve product standards, a new tool is designed for making horseshoe products (as shown in Figure 17). This tool can be used as a printing tool for horseshoe. By improving work layout and method, it will increase the productivity of SME and improve the quality of horseshoe products to make them more standardized.
