CASE STUDY

Retrieval of broken file and retreatment of previously treated mandibular left second molar

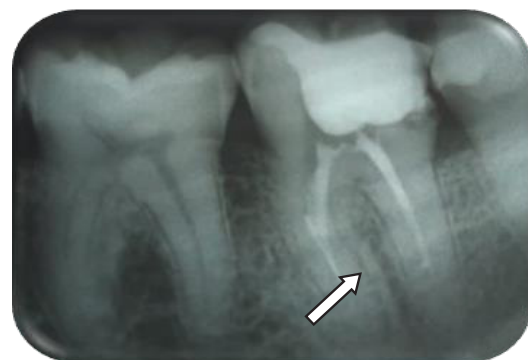
Figure 2. Preoperative radiograph of tooth 37 shows a long, thin radiopaque area in the middle third of the mesial root canal indicating a file fragment

Preoperative periapical radiograph examination of tooth 37 showed a radiopaque area on the crown of the tooth and on the root canal, showing that the tooth had been obturated using gutta percha. In the middle third of the mesiobuccal root canal, a radiopaque of approximately 5 millimeters was detected which indicated a file fragment in the root canal. Overall, the root canal filling appeared non-hermetic (Figure 2).

The presence of file fragments in that root canal of tooth 37 could interfere with the cleaning process in the root canal system if not removed. Tooth 37 was diagnosed with deep caries, previously treated with asymptomatic apical periodontitis accompanied by a foreign body.

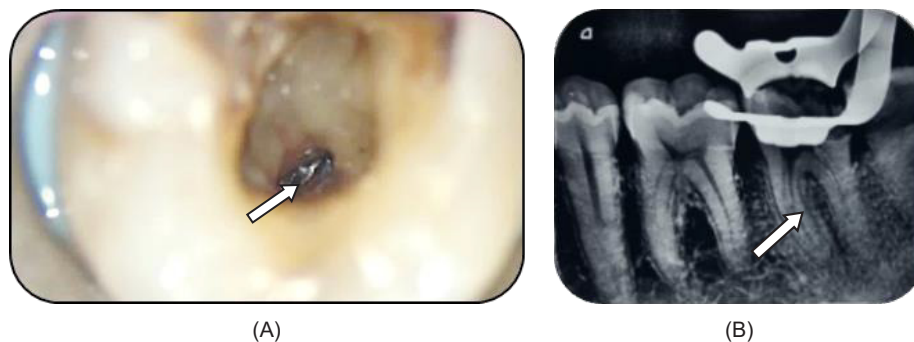
Figure 4. Image of changes in the position of the *file fragments* that have moved in a coronal direction (A); Radiographic image periapical tooth 37 after all root canal filling material and *file fragments* were removed (B)

In this case, the file fragment was located in the mesiobuccal root, and the position of the file fragment in the root canal was checked with an endodontic microscope. The area around the file fragment was loosened with a #10 K-file using satelec. Loosening of the root canal walls was carried out using a Satelec ultrasonic scaler with a titanium-niobium tip with a length of 20 mm and a taper of 3%. An endodontic microscope was used to check the position of the file fragments. The file fragments were removed using distilled water which was sprayed from a 5 ml syringe followed by retrieval of the file fragments using endo suction to prevent the file fragments from moving to other root canals. The mesiobuccal root canal was checked using an endodontic microscope and confirmed by taking a periapical radiograph to ensure that there were no file fragments left.
