Study of the Effect of Humidity and Pollutants on the Performance of 20 kV Arrester Isolators

ABSTRACT — An arrester is a device that serves to protect equipment from dielectric failure caused by lightning impulses, switching surges, or voltage spikes that exceed an equipment's dielectric capability. The majority of arresters have an event counter installed, which is used to track how frequently they have been in use. In humid and heavily polluted environmental conditions, it is very easy for surface discharge to occur on the isolator. Surface discharge is a discharge that occurs in an area directly related to a dielectric surface that has an excess electric field, thus triggering a discharge. If a surface discharge continues to happen, it can result in a flashover. Flashover that hits part of the event counter can make the event counter experience error, so it does not show the correct number. In addition, the performance of the event counter will be disrupted. For this reason, it is necessary to test the arrester insulators with three schemes: clean condition insulators, humid condition insulators, and insulators with humid and polluted conditions. In this experiment, pollutants

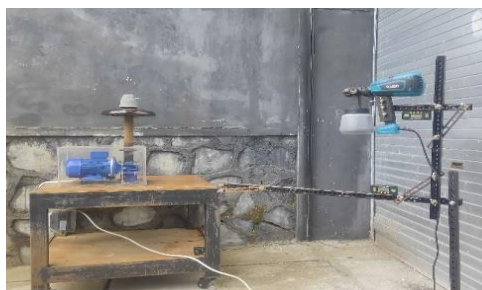
Figure 3. Pollutant sprayer.

This pollutant sprayer is one of the key pieces of equipment in this study. This device consists of several parts, such as a spray gun, a motor, and a motor speed regulator. This device applied a pre-made pollutant to the insulator part of the arrester by spraying it evenly on the test object. Figure 3 shows the pollutant sprayer device.

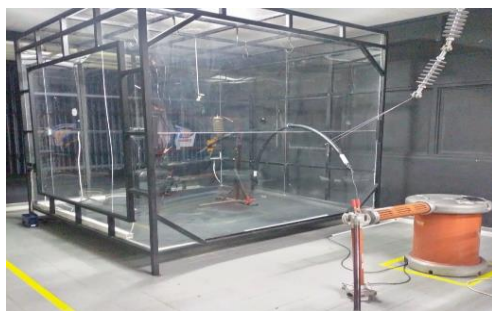
Figure 4. Testing chamber.

This test is highly dependent on surrounding conditions, particularly humidity. A chamber capable of isolating the humidity inside the chamber from the humidity of the surrounding environment is required to maintain a specific humidity level. This chamber, with dimensions of 250 cm × 250 cm × 270 cm, was the testing ground for the arrester. Figure 4 depicts the utilized chamber.

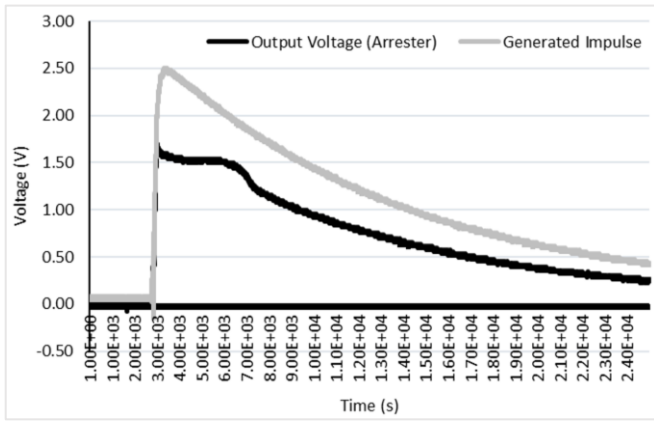
Figure 5. Impulse graph of the impulse voltage.

In this test, it was known the voltage at which the arrester cut off the voltage from the given impulse voltage. Figure 5

depicts a graph of the impulse voltage generated by the impulse generator and the impulse voltage after being cut by the arrester.

Based on Figure 5, it can be seen that the impulse graph is truncated. The voltage drop occurred because the voltage flowed through the arrester and was drained to the ground. This test was carried out ten times to accurately see the cut-off voltage value of the arrester being tested. Due to the presence of a voltage divider circuit in the measurement circuit, there was a multiplier factor of 28.1 kV for every 1 V of measurement in the measurement. Table II is the data of the cut-off voltage of the arrester.

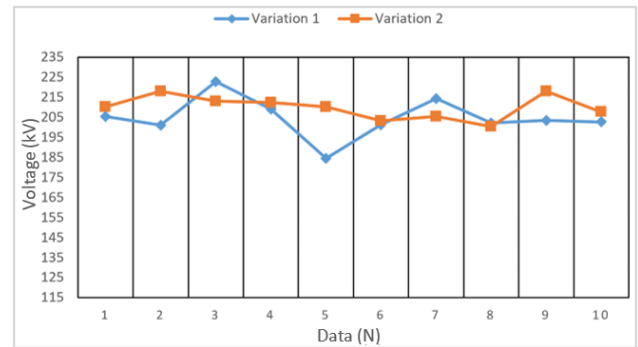
Similar to the previous test, this test utilized two auxiliary electrodes. The distance between the electrodes remained unchanged from the prior test. The test was carried out ten times. Prior to the test, the chamber's humidity was adjusted and allowed to stand for some time to ensure that the humidity in the chamber was evenly distributed. Figure 9, Figure 10, and Figure 11 are the results of surface discharge testing in humid conditions.

It can be seen from Figure 9, Figure 10, and Figure 11 that the BDV values for each humidity condition are different. There was a decrease in the BDV value although the value of the BDV change was not significant. It is also evident from the average BDV value at each humidity level. At 80% humidity, the BDV value was 212.4 kV. At 85% humidity, the BDV value was 207.3 kV. At 90% humidity, the BDV value was 200.8 kV. When compared with the BDV value in the arrester test under

clean conditions and in room conditions, it can be seen that the BDV decreases as the chamber's humidity increases. This condition is in accordance with [26].
