EVALUATION ON THE IMPLEMENTATION OF EARLY WARNING SYSTEM FOR DEBRIS FLOW IN MERAPI AREA (CASE STUDY AT BOYONG RIVER)

Ali Cahyadi Achmad

Executive of Water Resources Management, Public Works Office of North Maluku Province, Ternate, Indonesia
arnalthan@gmail.com

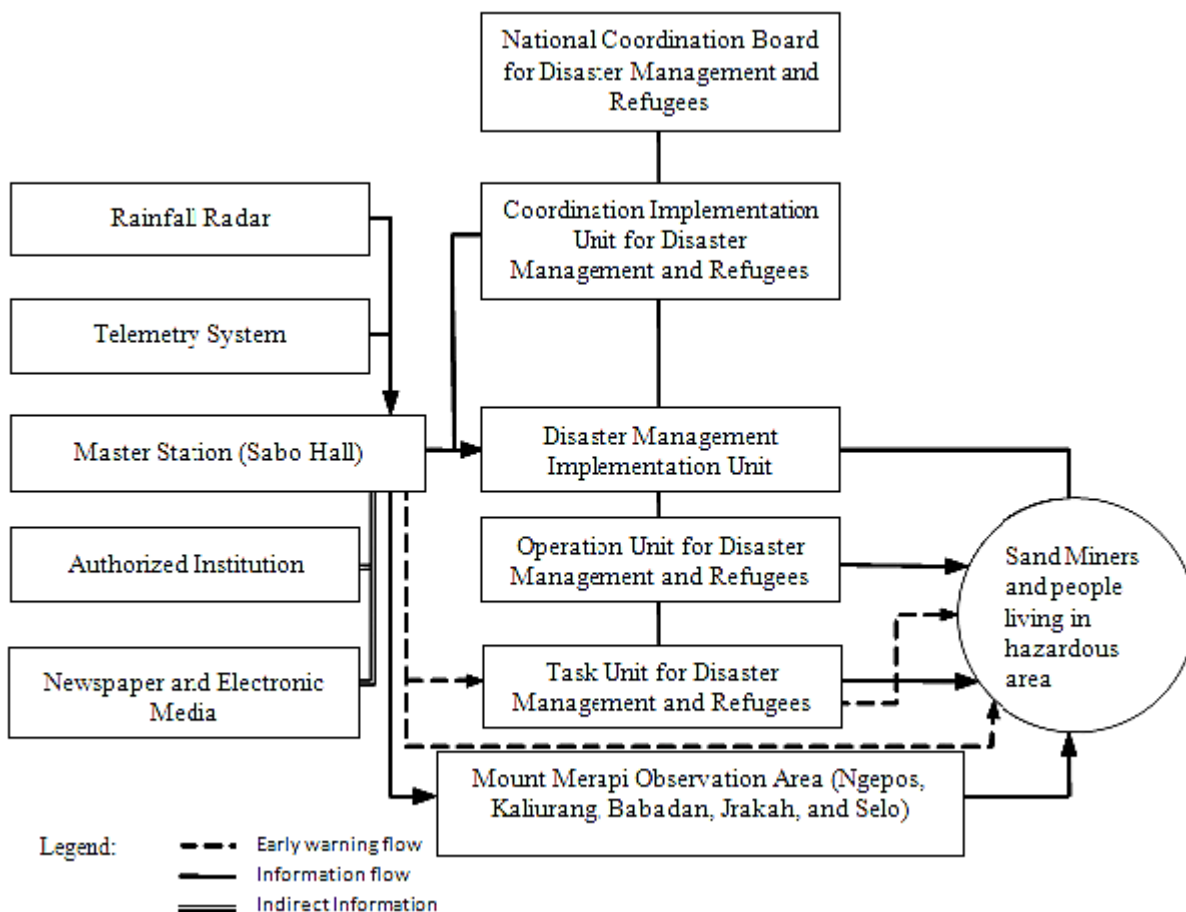
The early warning and forecasting system in Mount Merapi basically refers to the early warning and forecasting system as seen in Figure 2. For the disaster management in the Sleman Regency area, the Regent of Sleman established the Disaster Management Implementation Unit (*Satlak PB*) that directly chaired by the Regent himself and assisted by vice chairman, secretary, treasurer, and sections. According to the information flow related to the forecasting and early warning system in Mount Merapi, the Sabo Office gives information to *Satlak PB*, which directly supervises some Disaster Management Operation Unit led by the head of the sub-district. The Disaster Management Operation Unit coordinates with

Figure 2. Scheme of Forecasting and Early Warning System on Mount Merapi Area.

The early warning system on Mount Merapi area is basically refers to the early warning system scheme, as seen in Figure 2. According to the scheme, Sabo Office as the master station receives dangerous signal/data from telemetry stations spread over Mount Merapi area and distributes the information to authorized institutions, in order to deliver early warning to residents who live in disaster-prone areas.

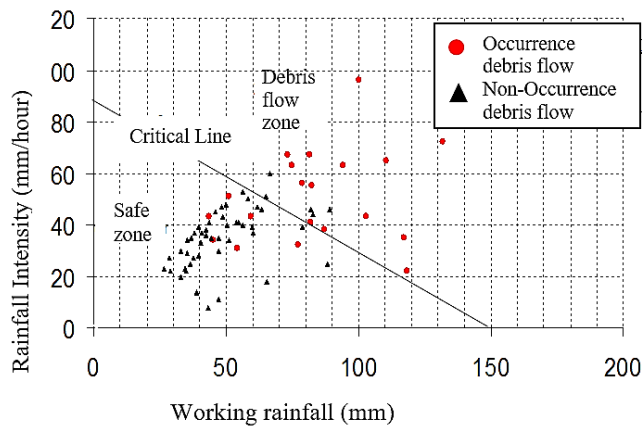
Soil saturation can also be the trigger factor for the debris flow, since even though the rainfall amount at the debris flow event was less than 60 mm/hour, and such high intensity rainfall happened 3 (three) or 4 (four) days in a row before the occurrence, the soil saturation may increase and induce the debris flow. This point may cause some debris flow to be positioned under the critical line which can be seen in Figure 3 and Figure 4.

Figure 3. Prediction of debris flow event with 7 (seven) days working rainfall.

From the debris flow forecasting graphs, it can be seen that early warning on debris flow ought to be delivered when the rainfall reach level of 50 mm/hour to 55 mm/hour. In the system of debris flow forecasting information delivery, the estimated travel time of debris flow to reach the observed points which are the dense settlement along the Boyong River side on Pulowatu (Location 2) and the sand mining activity area in Boyong River upstream BOD6 (Location 2) should be conducted.

Estimation was analysed also by considering working rainfall for 4 (four) days before the debris flow event. Though it is rare to have rain fall for 7 (seven) days in a row in Mount Merapi, it is mostly happen for about 4 (four) consecutive days. The hydrology model calculation result for debris flow forecasting with 7 (seven) days working rainfall and 4 (four) days working rainfall can be seen in Figure 3 and Figure 4.

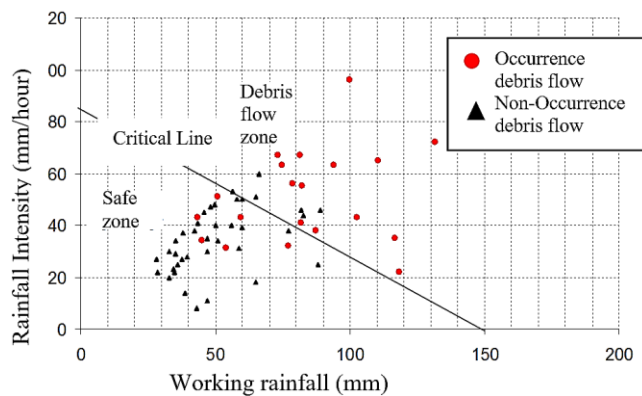
Figure 4. Prediction of the debris flow with 4 (four) days working rainfall.
